**COPLAY CREEK
STREAM RESTORATION PROJECT**

Wildlands Conservancy

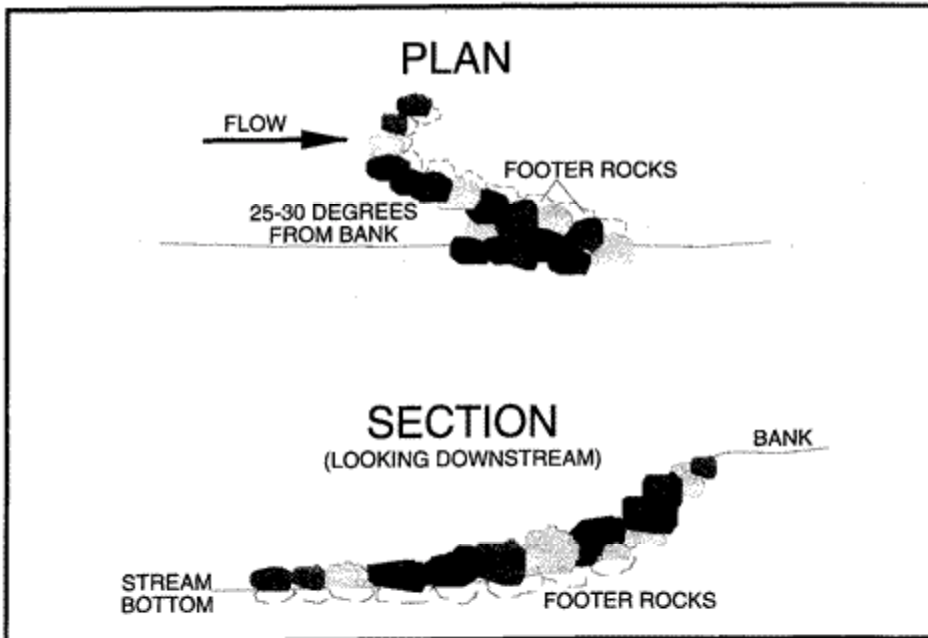
SINGLE LOG DEFLECTOR STANDARD DRAWING
